# Restoring *Oncorhynchus mykiss* in an Urbanized Environment

## Codornices Creek Watershed Restoration Action Plan

Urban Creeks Council  
Emma B.L. Gutzler

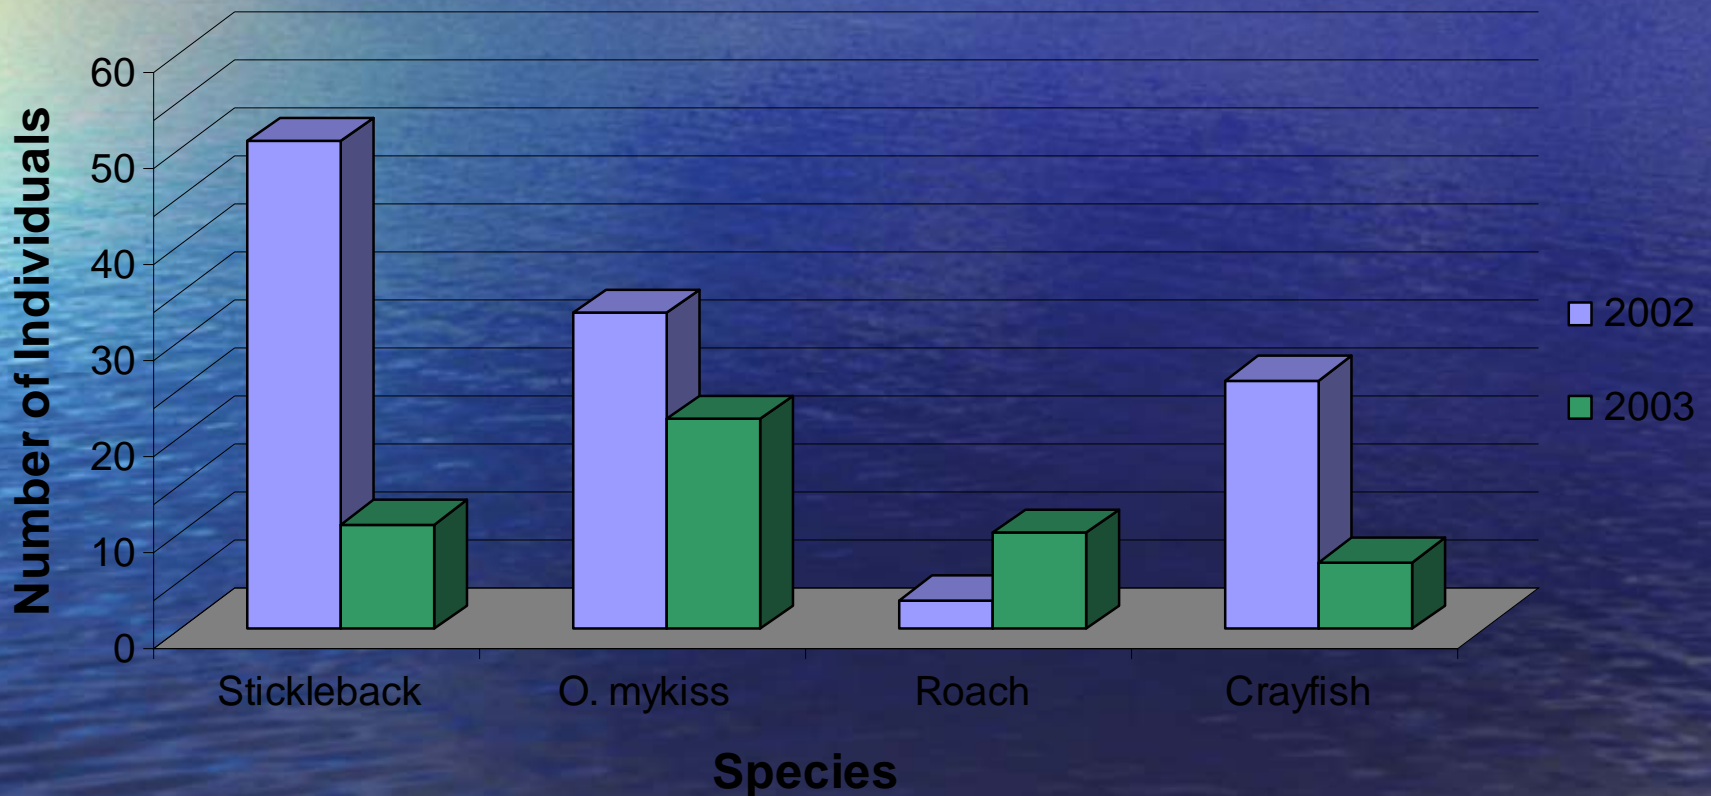
## Downstream Migrant Trap Codornices Creek

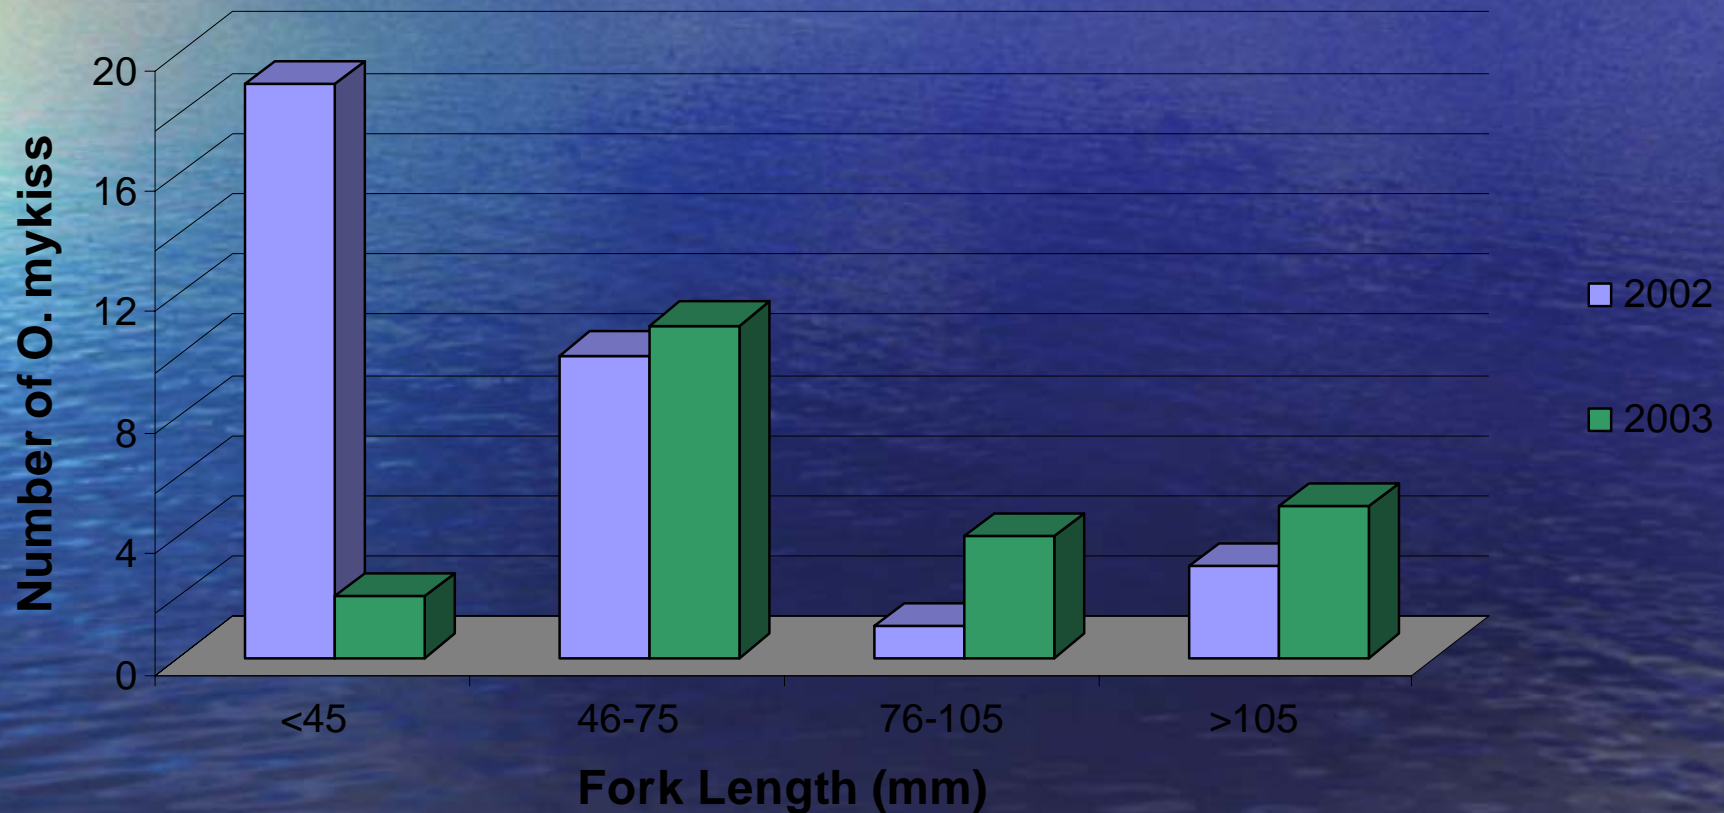
Downstream Migrant Trap *O. mykiss*  
Size Range Codornices Creek

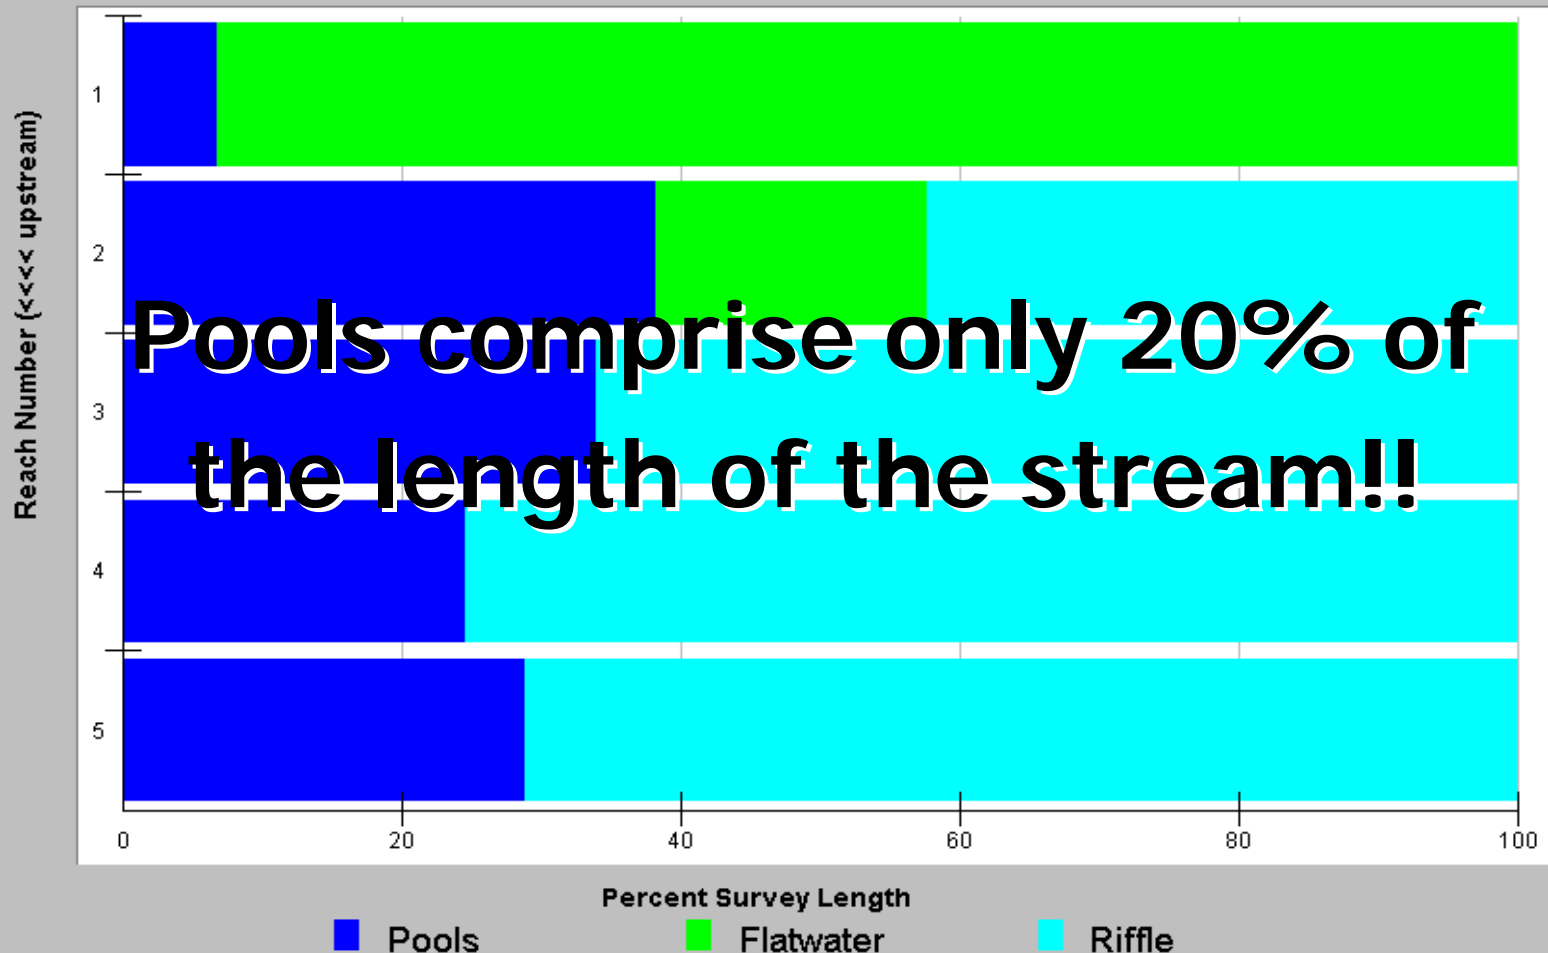
Habitat Type by Length for Codornices Creek 2003

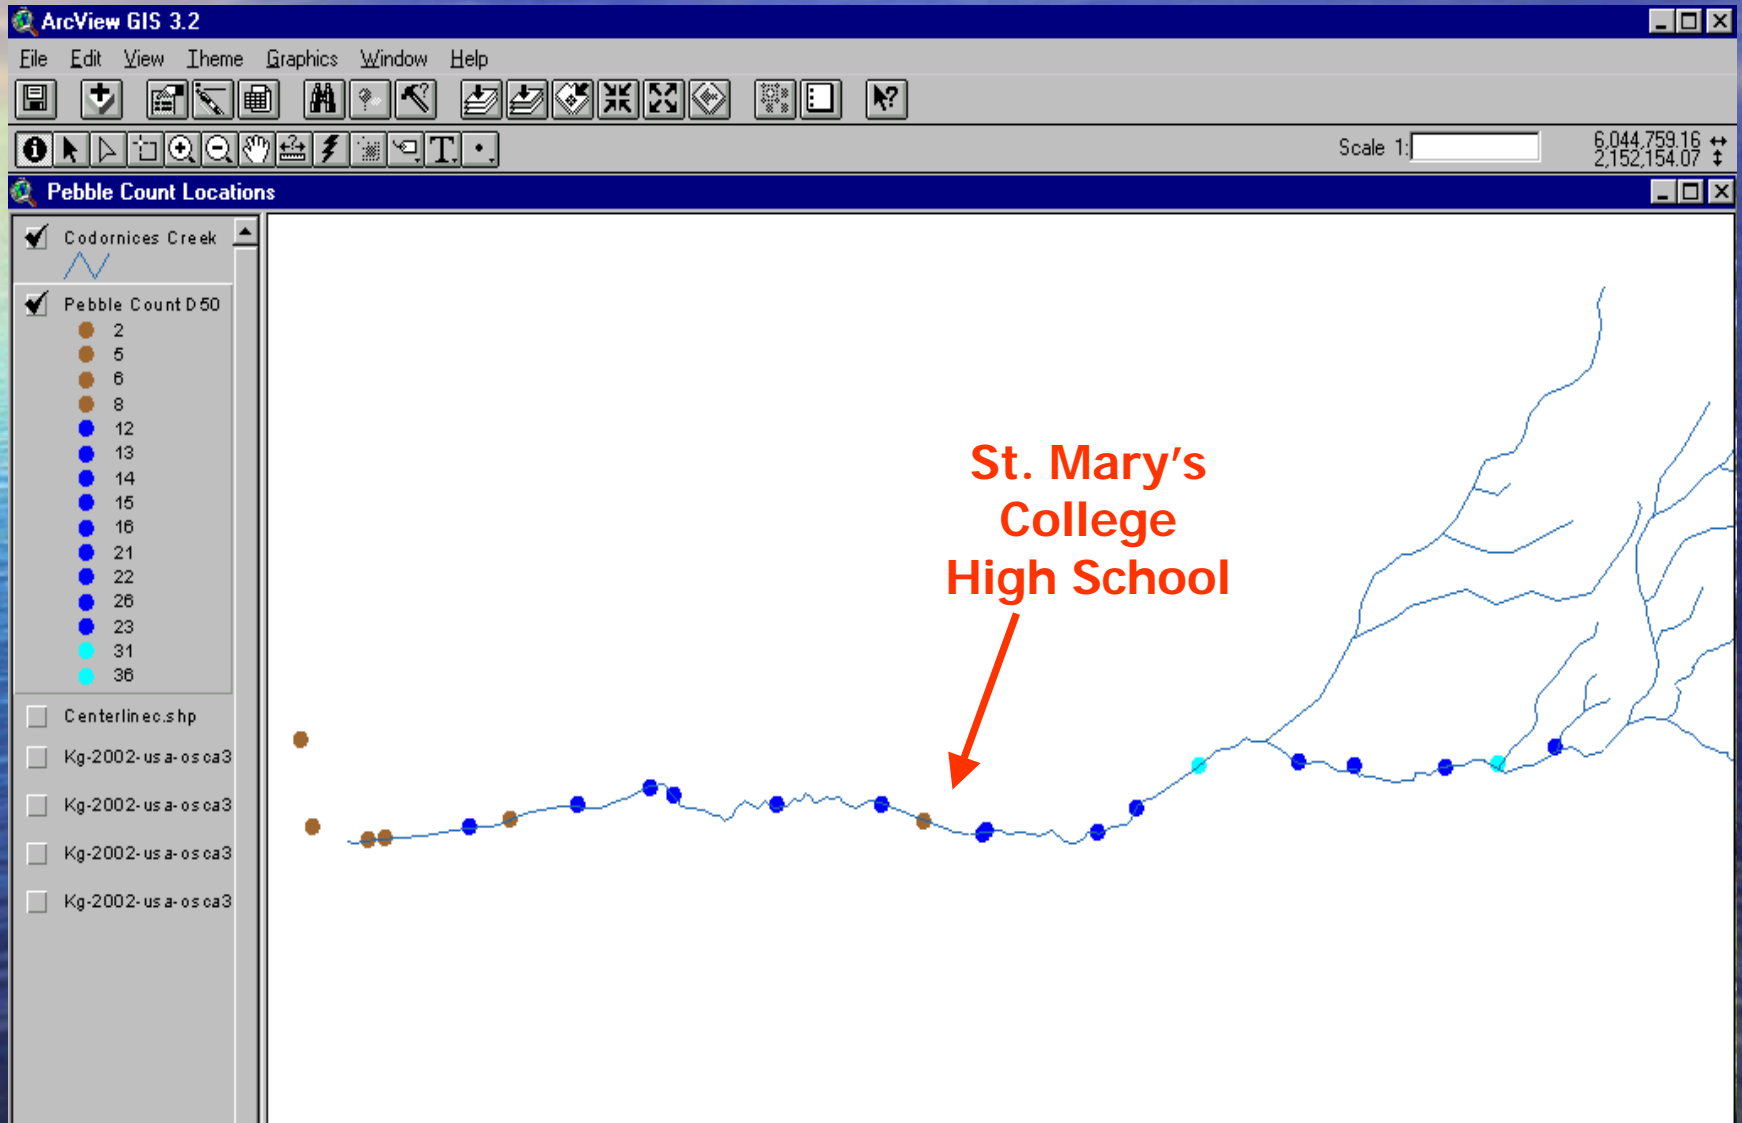
- Median Particle Size
  - Streambed particle sizes for successful steelhead spawning, egg incubation and fry emergence range from 10-45 mm (Kondolf 1993)
- Embeddedness
  - 25% or less is considered suitable for salmonid spawning (CDFG 1998)

Streambank erosion occurring at St. Mary's College High School appears to be adversely affecting downstream spawning gravel and embeddedness.

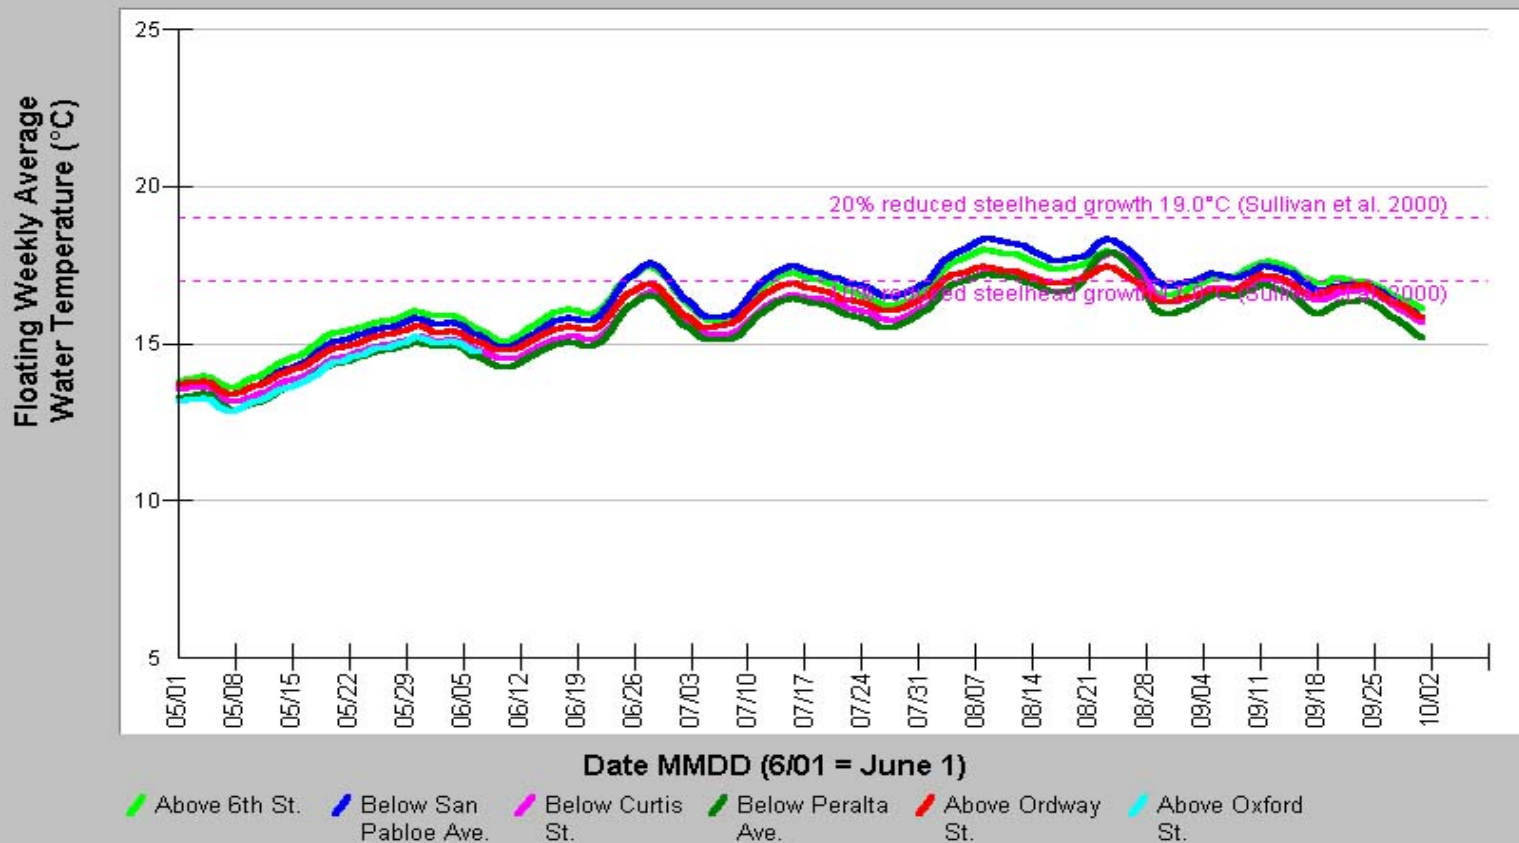
Floating Weekly Average Temperature at Codornices Creek Sites  
2003

Water temperatures are slightly high during the summer

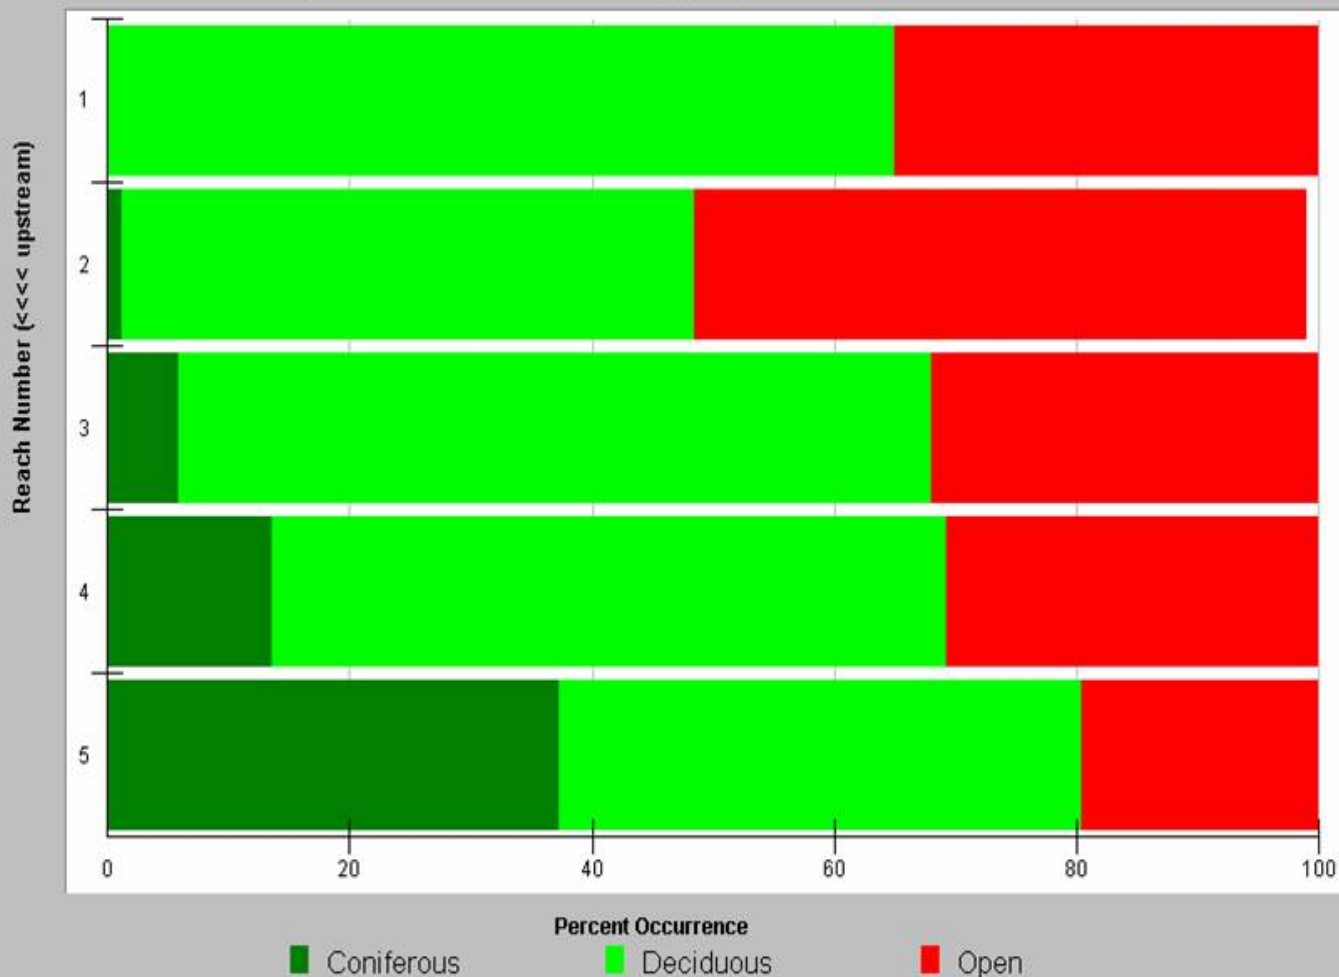
Canopy Cover from Habitat Typing of Codornices Creek 2003

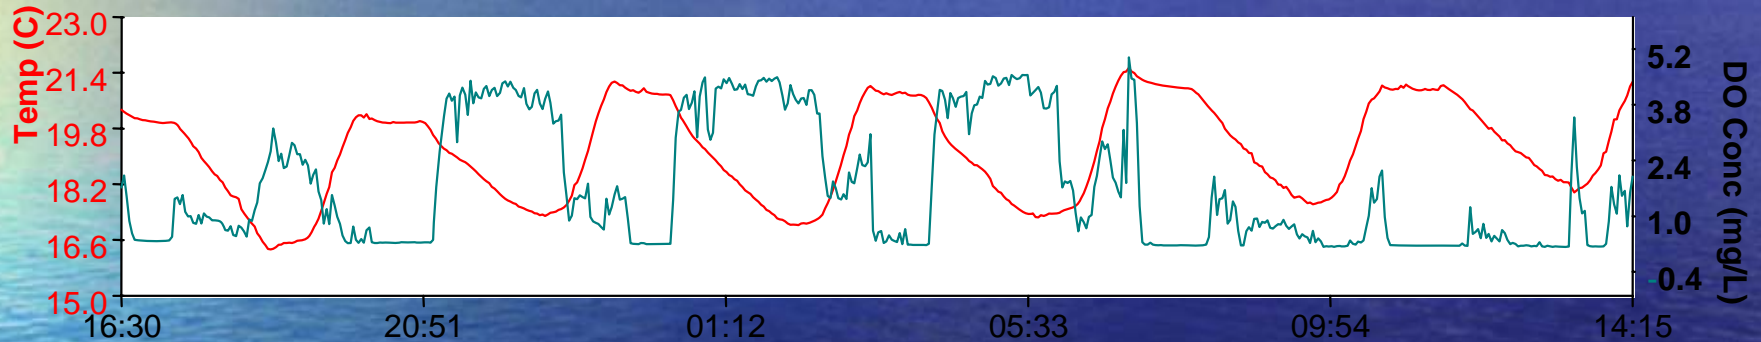
**COD020 Codornices @ 2nd St**

September 3 - 9, 2004

Dissolved Oxygen levels are low during the summer

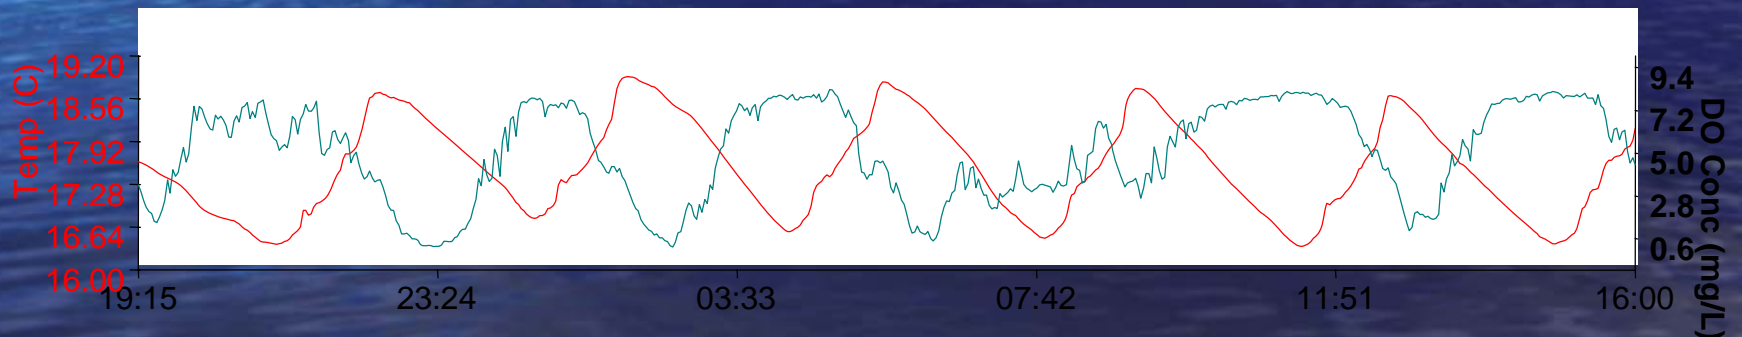
**COD080 Codornices @ Albina**

September 3 -9, 2004

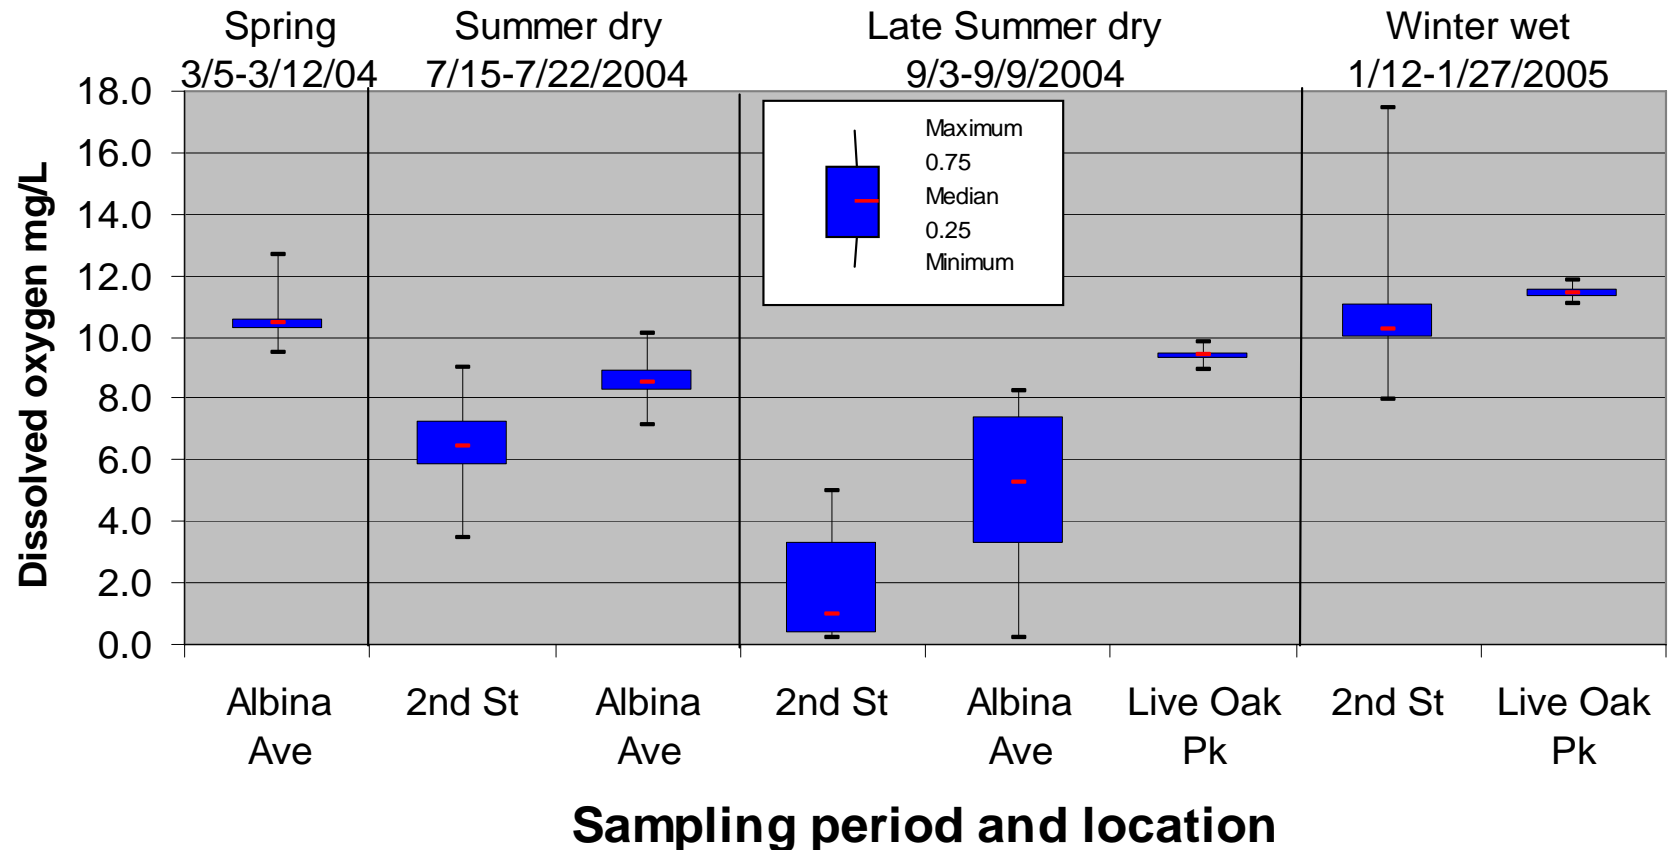
## Codornices Creek temporal variation in dissolved oxygen, mg/L

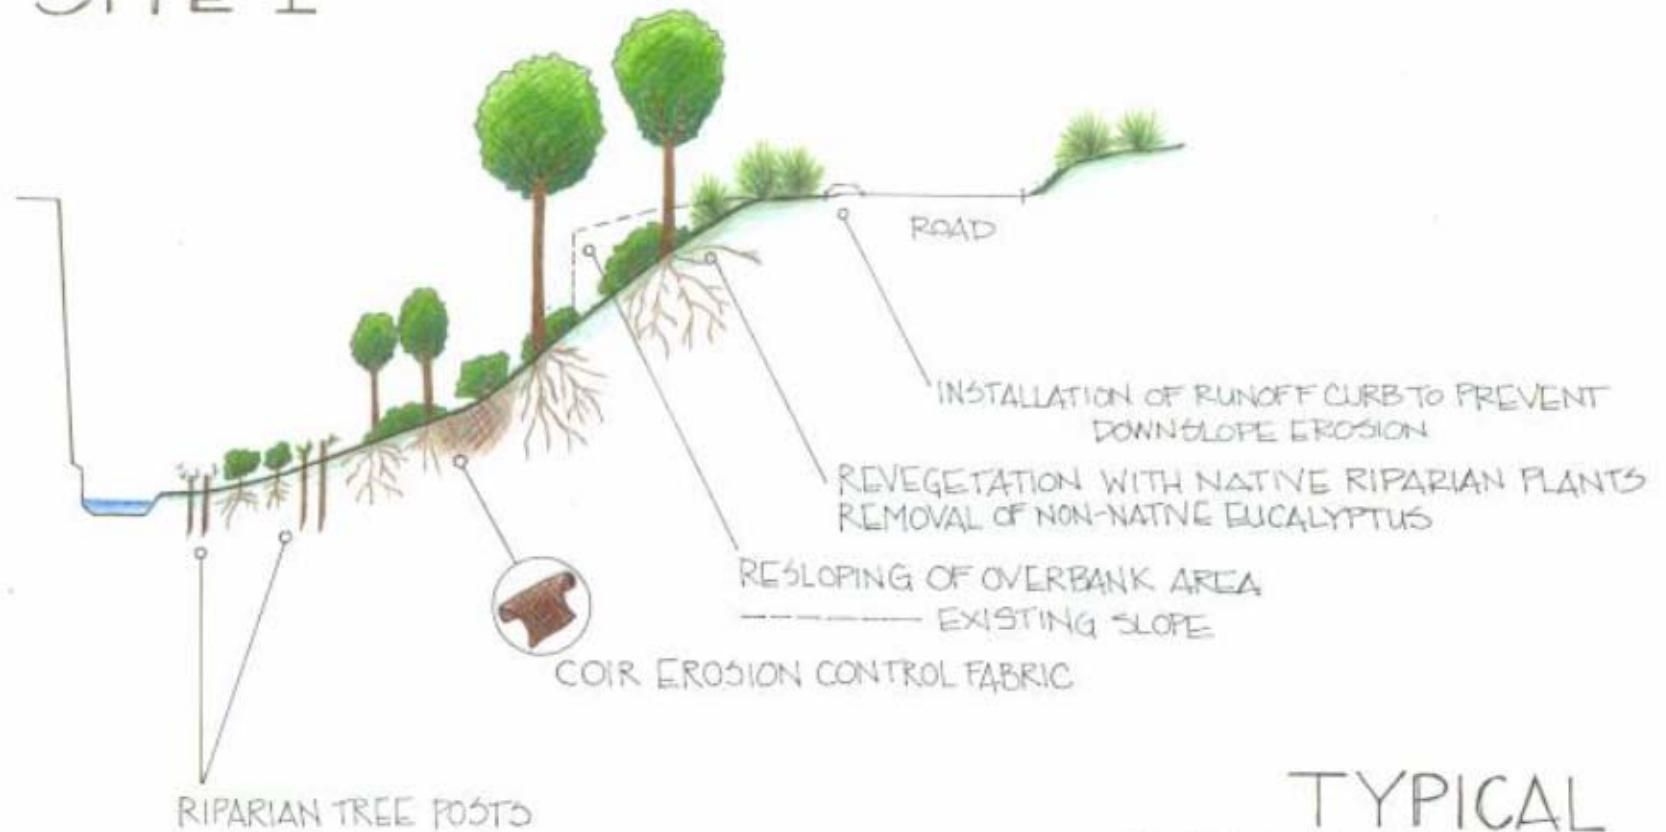
# SITE 1

## TYPICAL CROSS SECTION

CODORNICES CREEK  
AT SAINT MARY'S  
COLLEGE HIGH SCHOOL
